ARBORICULTURAL ASSESSMENT & **IMPACT REPORT**

BLESSINGTON LRD CO. WICKLOW

Project No. TBLE002

Project nameDateBlessington LRD04/09/24

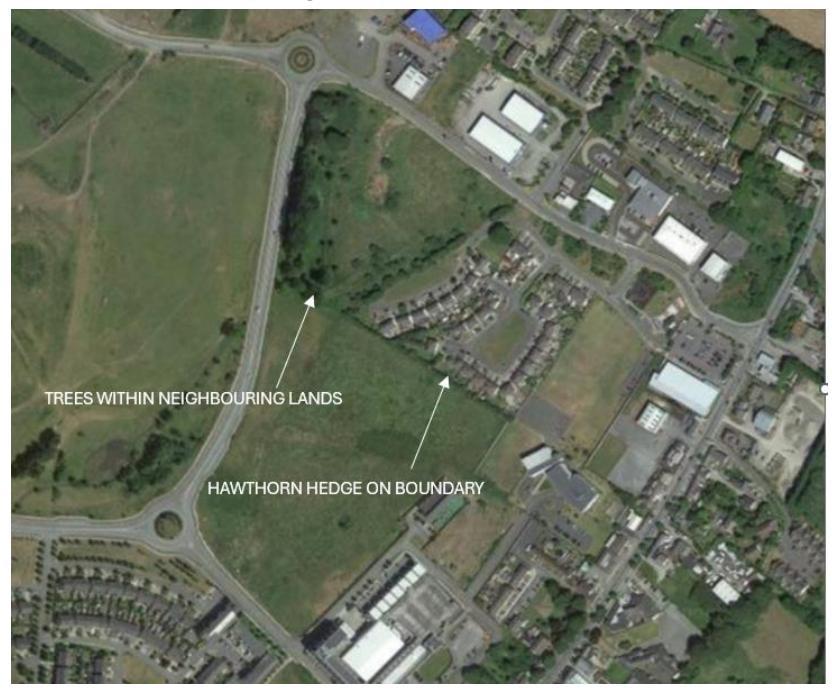
The remaining woody vegetation is composed of a hawthorn hedge on the northern boundary with the Oak Drive housing development (images 2 & 4). The hedgerow conforms to classification WL1 (Fossitt 2000). This hedgerow is on average 4m high and contains no standard trees. The neighbouring parcel of land to the north of the subject site contains a number of mature oak (*Quercus robur*) and ash (*Fraxinus excelsior*) trees (image 4).

The older trees in this location are likely to be remnants of the Blessington Demesne plantings. A number of these trees overhang the subject site by up to 6m. No roots

Image 2. Location of hedge and trees within neighbouring lands

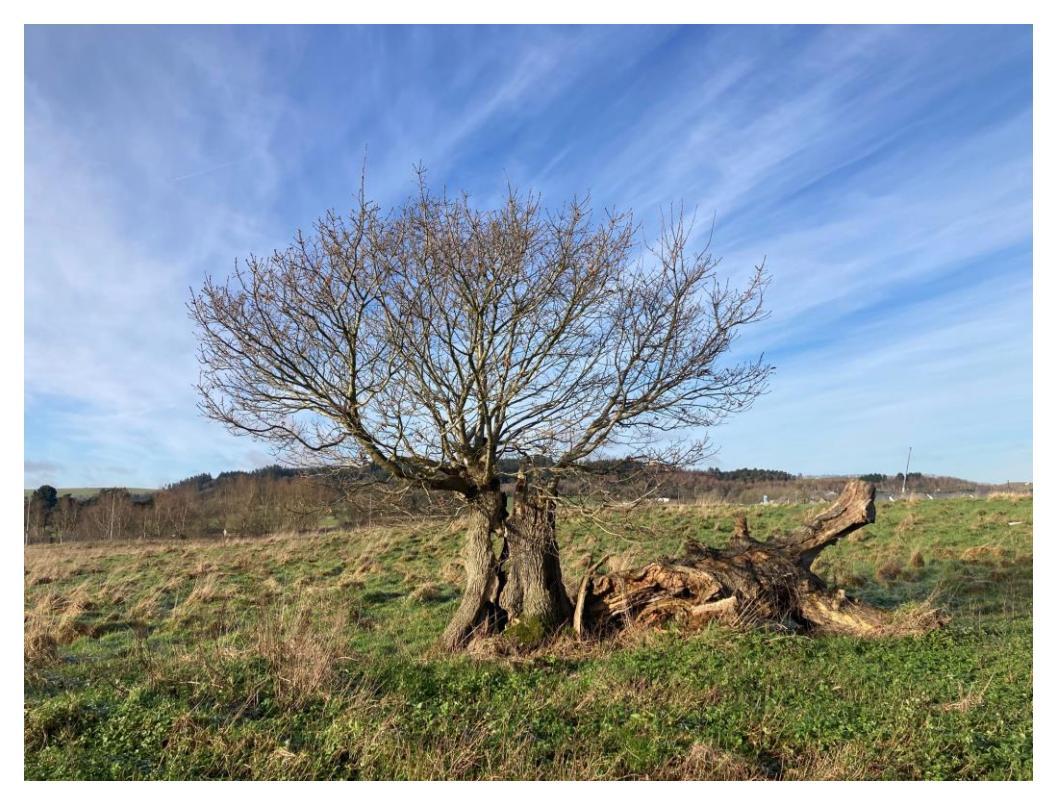
One dying oak tree (Quercus robur) is located on the site (image 3). It has extensive basal

decay and fire damage at base and has very limited potential outside of its current environment. This tree conforms to category U within BS5837 (2012).

Image 3. Tree within centre of site. Note extensive basal decay

Tag number	Species	Age Class	Vigour	Comments	Preliminary Recommendations	Category	Long-term potential (years)	Dbh mm	Height m	Spread m N, E, S, W
	Common oak		Very	In a state of advanced decay with a						
1	Quercus robur	Mature	Poor	large basal cavity	Fell	U	<10	550	4	3,3,3,3

The proposed development will require the removal of the one category U tree on the site. No impact on trees within the neighbouring site is envisaged as the existing watercourse will negate the possibility of tree roots entering the site and the general area will be incorporated into the open space provision.

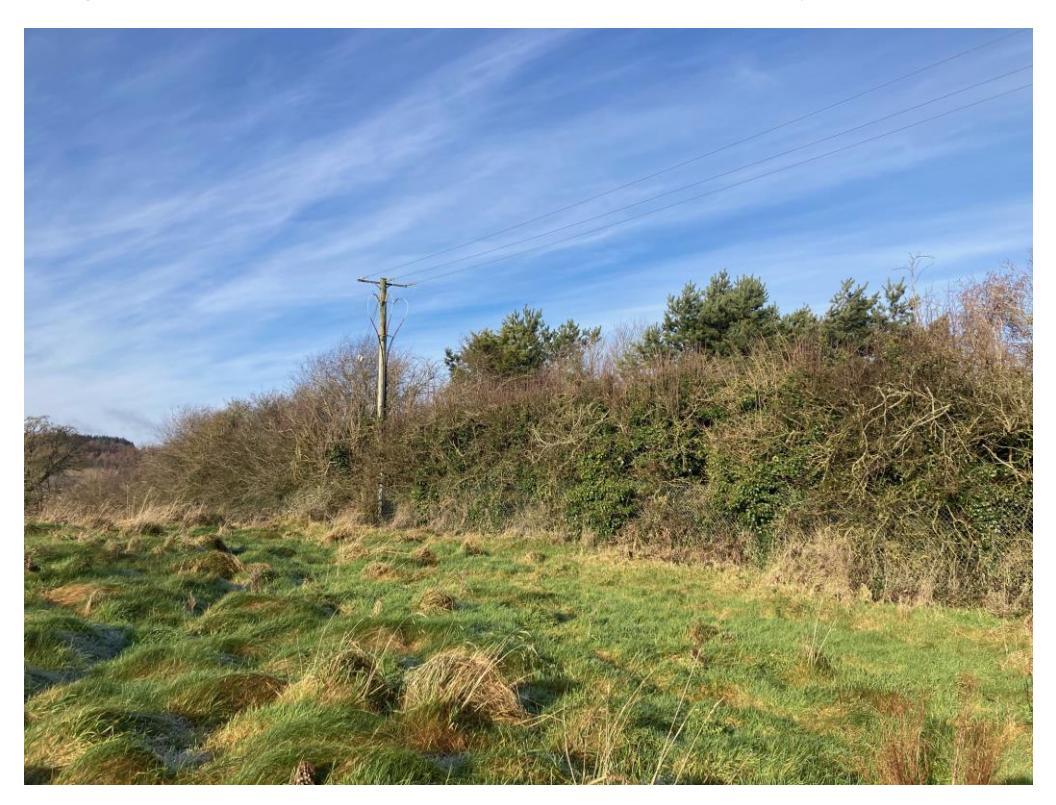
Image 4. Hawthorn hedge on boundary with Oak Drive

The northern boundary hedge will also be incorporated into the open space provision of the site and will be unaffected by the works.

Tree / hedge protection fencing shall be erected prior to the main mobilisation of site plant and infrastructure. It shall be retained in situ for the duration of the site works and only removed when soft landscaping works require its removal (refer to drawing TBLE002 102 Tree Protection)

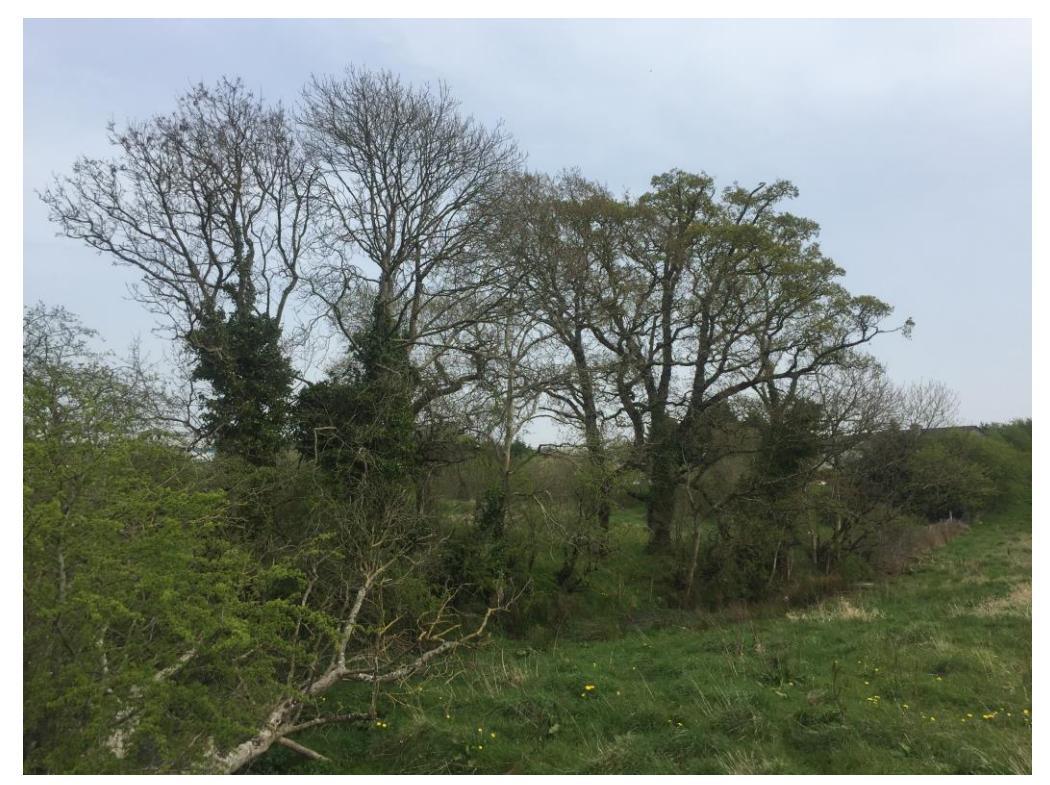
from these trees are likely to extend into the site as there is a stream separating both sites in this area (image 5).

Image 5. Trees within neighbouring site
