Blessington LRD

Site Specific Flood Risk Assessment

230199-DBFL-XX-XX-RP-C-0002

October 2024

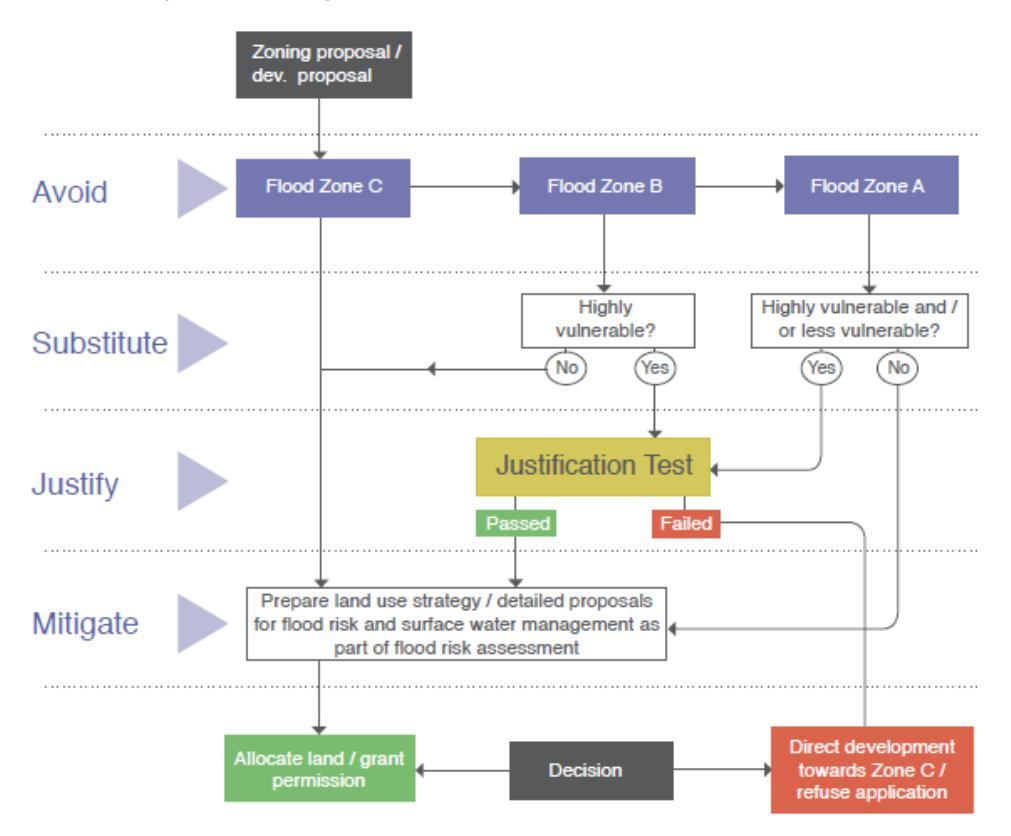
Figure 2-1 Extract from The Planning System and Flood Risk Management Guidelines (Fig 3.2: Sequential Approach Mechanism in the Planning Process)

This SSFRA will initially use existing flood risk information to determine the flood zone category of the site i.e. to determine whether the development is considered appropriate or whether a justification test is required (see Figure 2.1 below).

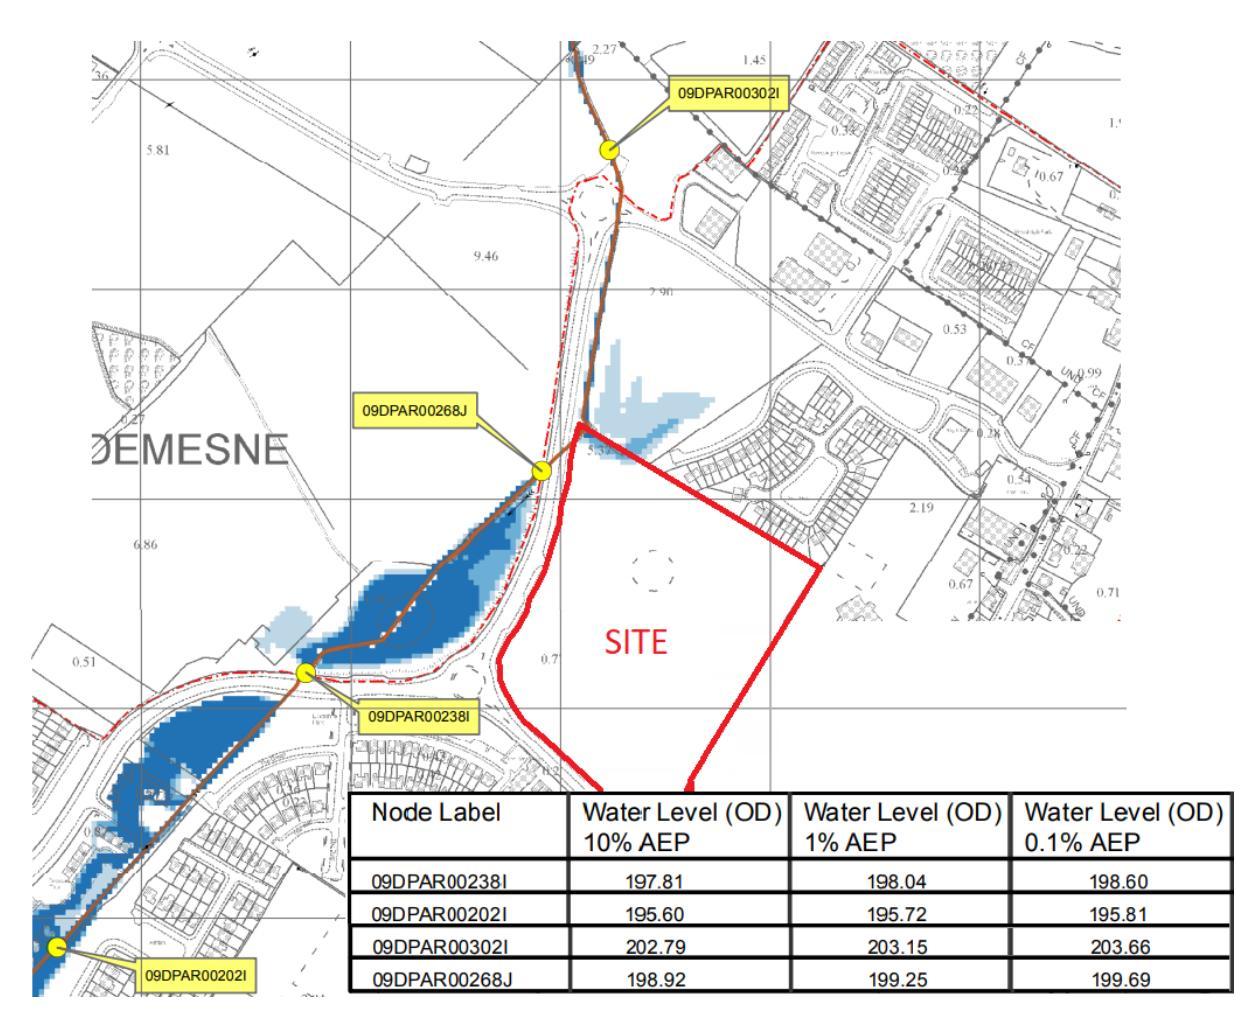
Figure 4-1 CFRAM MAP EXTRACT

The closest modelled node to the site is Node 09DPAR00268J, approximately 10m West of the site, see Figure 4-1 below.

Node 09DPAR00268J, 10% AEP fluvial flood level	+198.92m
Node 09DPAR00268J, 1% AEP fluvial flood level	+199.25m
Node 09DPAR00268J, 0.1% AEP fluvial flood level	+199.69m
Lowest Proposed FFL	+201.31m

The lowest proposed FFL (+201.31) is 1.62m above the predicted 0.1% AEP fluvial flood event associated with Node 09DPAR00268J (+199.69m).

The location of this node is shown on CFRAM Drawing E09BLE_EXFCD_F0_01 (Appendix A).

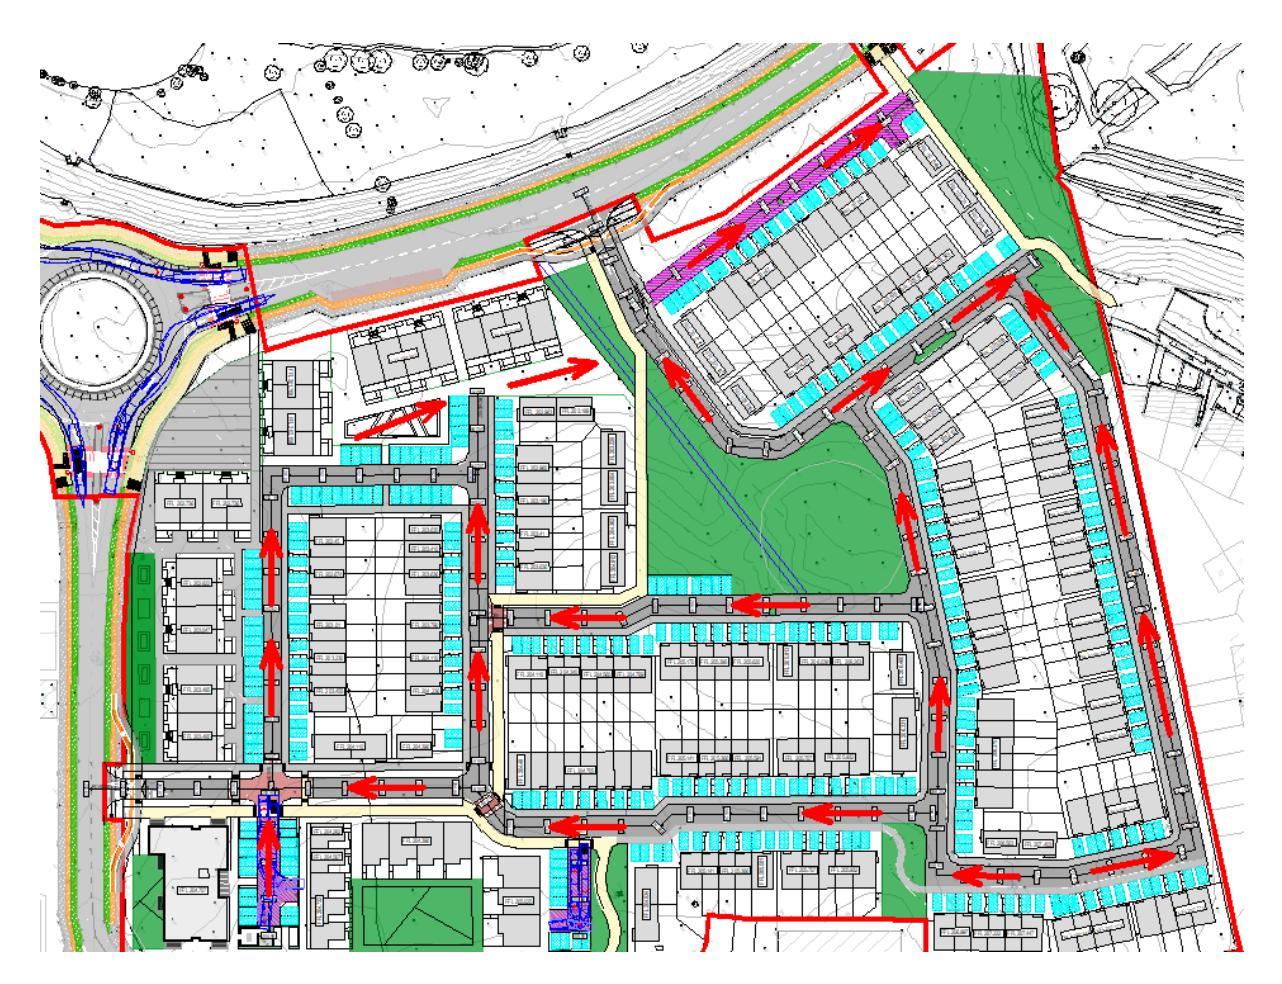
Figure 5-1 Flood Exceedance (>1%AEP) Overland Flow Routes

During storms greater than the 1% AEP pluvial event, the development's drainage network design may be exceeded and areas with low ground levels will begin to flood.

Designed site levels fall from the high point along its Eastern boundary, towards the open space in the Northern and corner. Overland flow is therefore directed towards this open space in the Northern and corner (refer to Figure 5.1).

Storms greater that the 1% AEP (exceeding the design capacity of the site's drainage system) may result in overland flow being directed towards open space areas and roads.

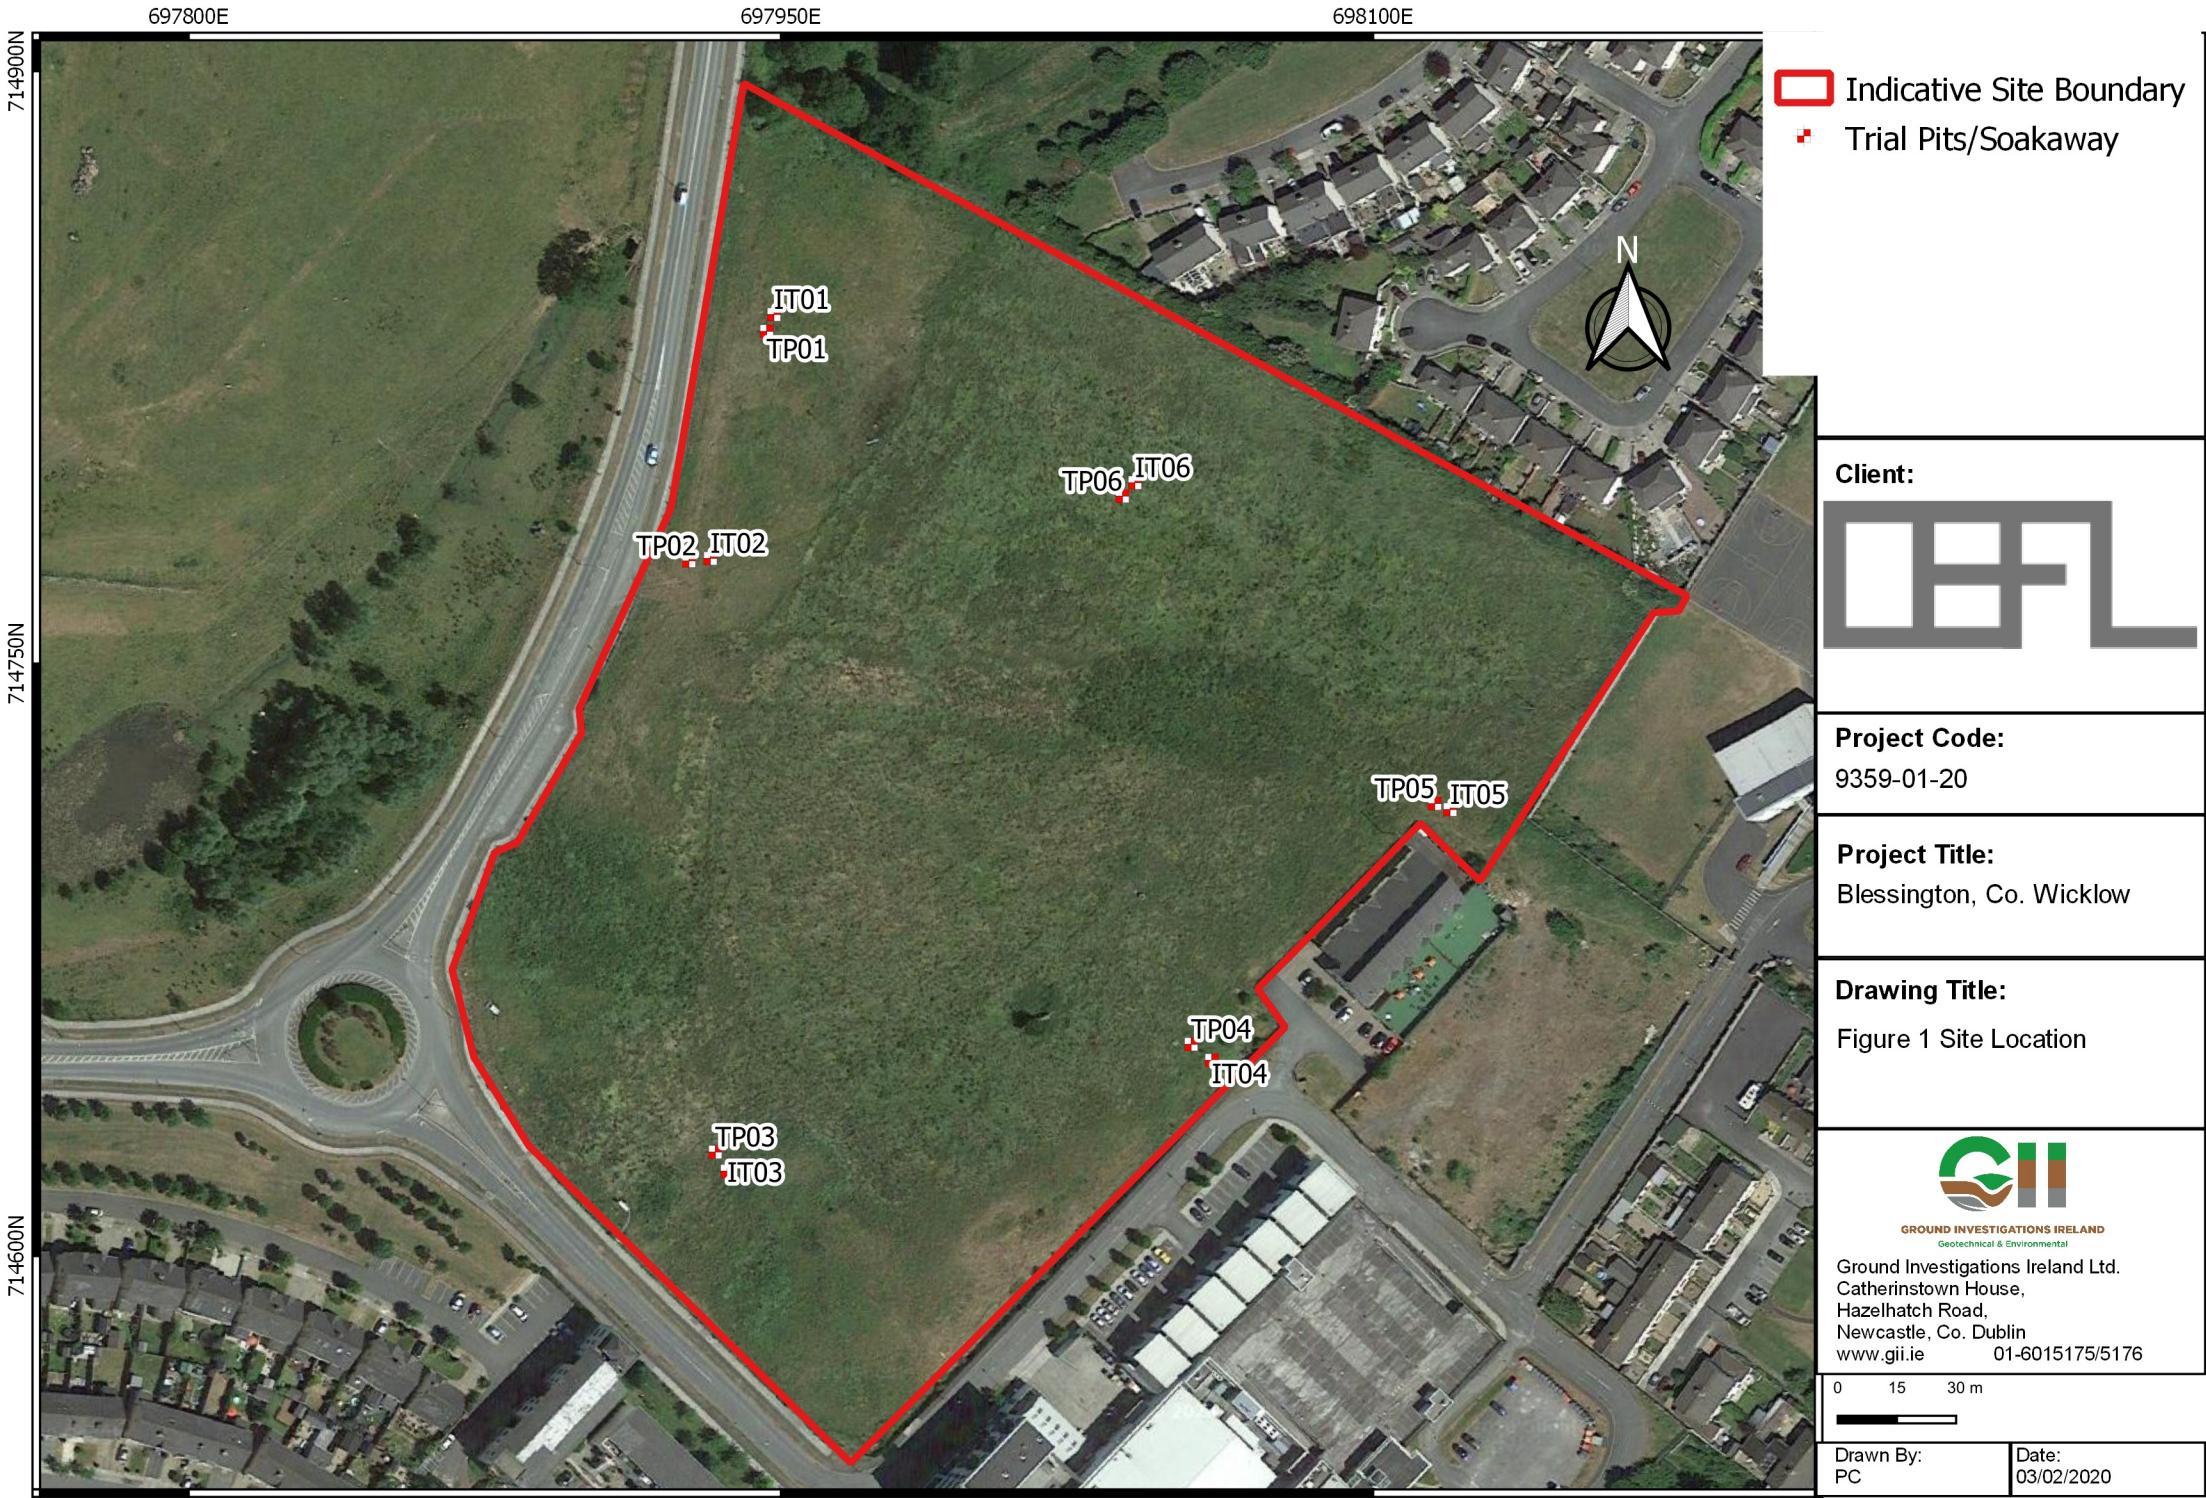
APPENDIX 1 - Site Location Plan

The soakaway testing was carried out in selected trial pits at the locations shown in the exploratory hole location plan in Appendix 1. These pits were carefully excavated and filled with water to assess the infiltration characteristics of the proposed site. The pits were allowed to drain and the drop in water level was recorded over time as required by BRE Digest 365. The pits were logged prior to completing the soakaway test and were backfilled with arising's upon completion. The soakaway test results are provided in Appendix 3 of this Report.
